# COLUMBIA

## ACCIDENT INVESTIGATION BOARD

REPORT VOLUME I  
AUGUST 2003

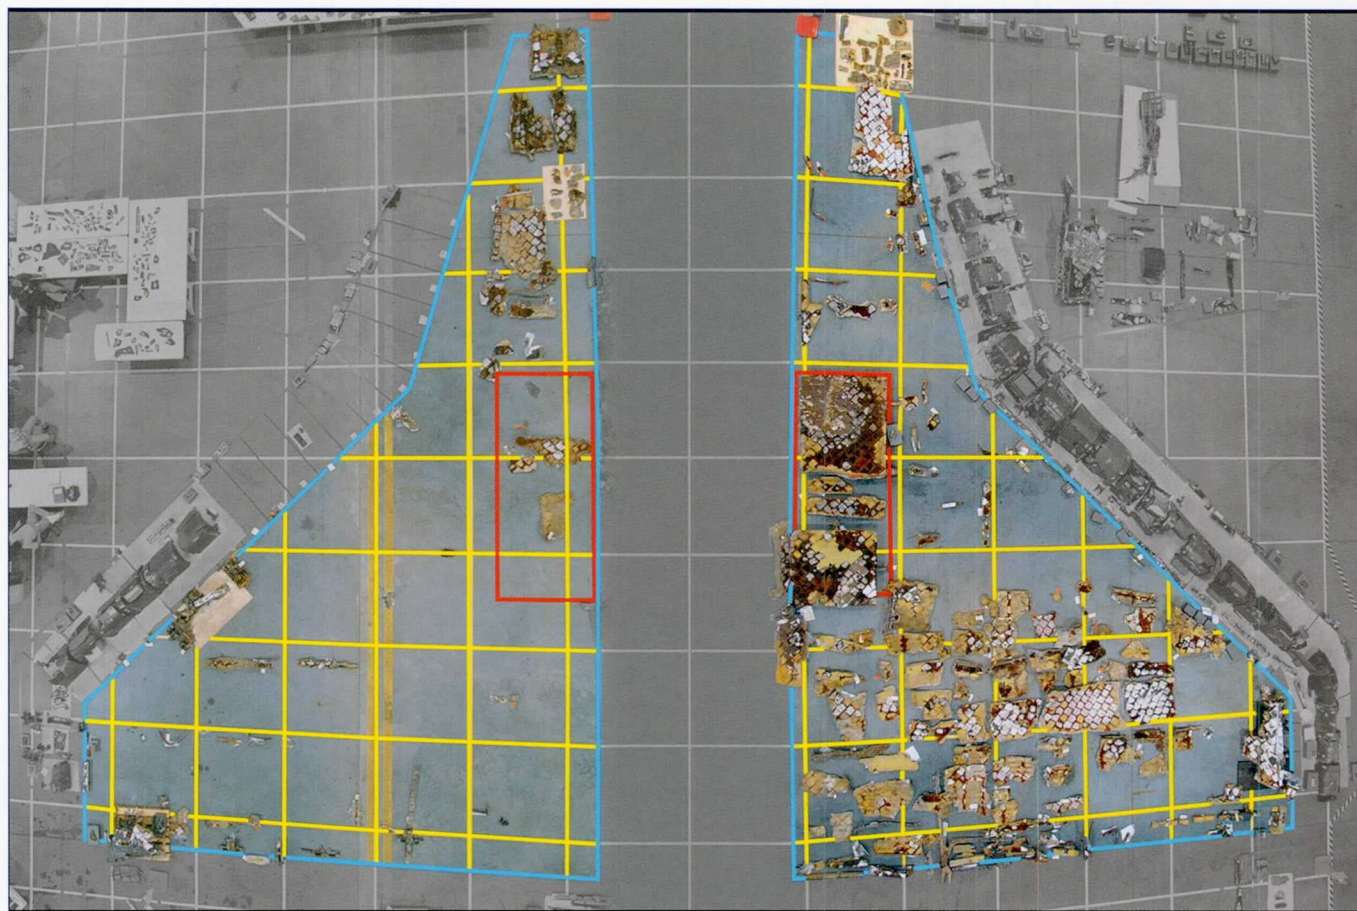
Detailed analysis of the debris revealed unique features and convincing evidence that the damage to the left wing differed significantly from damage to the right, and that significant differences existed in pieces from various areas of the left wing. While a substantial amount of upper and lower right wing structure was recovered, comparatively little of the upper and lower left wing structure was recovered (see Figure 3.7-1).

The difference in recovered debris from the Orbiter's wings clearly indicates that after the breakup, most of the left wing succumbed to both high heat and aerodynamic forces, while the right wing succumbed to aerodynamic forces only. Because the left wing was already compromised, it was the first area of the Orbiter to fail structurally. Pieces were exposed to higher heating for a longer period, resulting in more heat damage and ablation of left wing structural material. The left wing was also subjected to superheated air that penetrated directly into the mid-body of the wing for a substantial period. This pre-heating likely rendered those components unable to absorb much, if any, of the post-breakup heating. Those internal and external structures were likely vaporized during post-breakup re-entry. Finally, the left wing likely lost significant amounts of the Thermal Protection System prior to breakup due to the effect of internal wing heating on the Thermal Protection System bonding materials, and this further degraded the left wing's ability to resist the high heat of re-entry after it broke up.

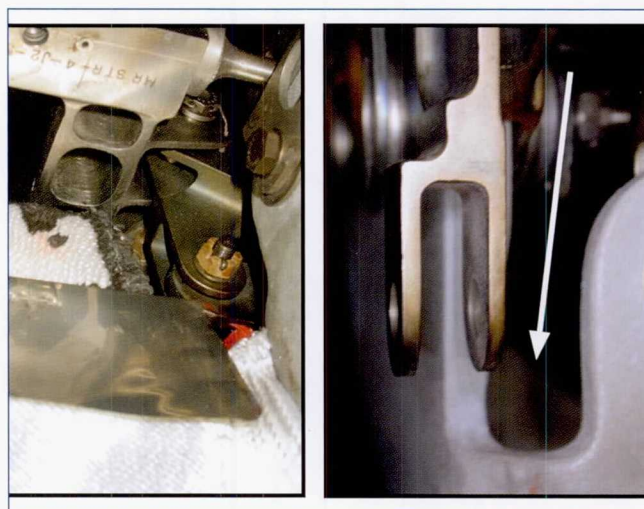
Figure 3.7-2. Each RCC panel has a U-shaped slot (see arrow) in the back of the panel. Once superheated air entered the breach in RCC panel 8, some of that superheated air went through this slot and caused substantial damage to the Thermal Protection System tiles behind this area.

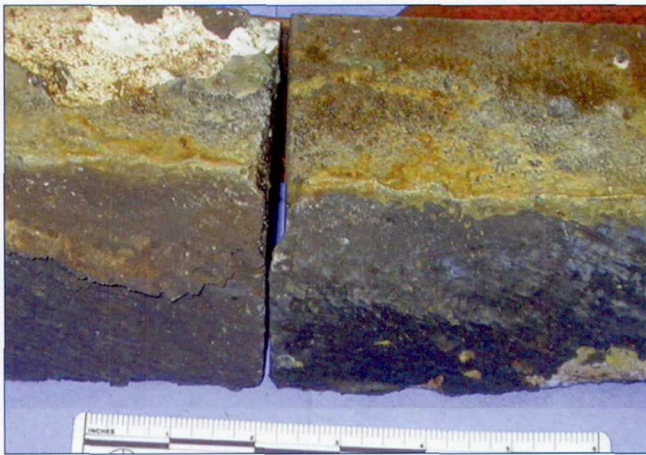
Figure 3.7-3. Superheated airflow caused erosion in tiles around the RCC panel 8 and 9 interface. The tiles shown are from behind the area where the superheated air exited from the slot in Figure 3.7-2. These tiles showed much greater thermal damage than other tiles in this area and chemical analysis showed the presence of metals only found in wing leading edge components.

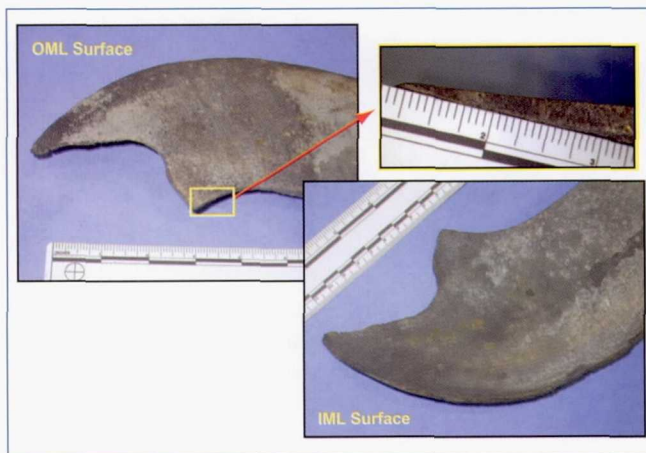
Figure 3.7-4. The outboard rib of panel 8 and the inboard rib of panel 9 showed signs of extreme heating and erosion. RCC erosion of this magnitude was not observed in any other location on the Orbiter.

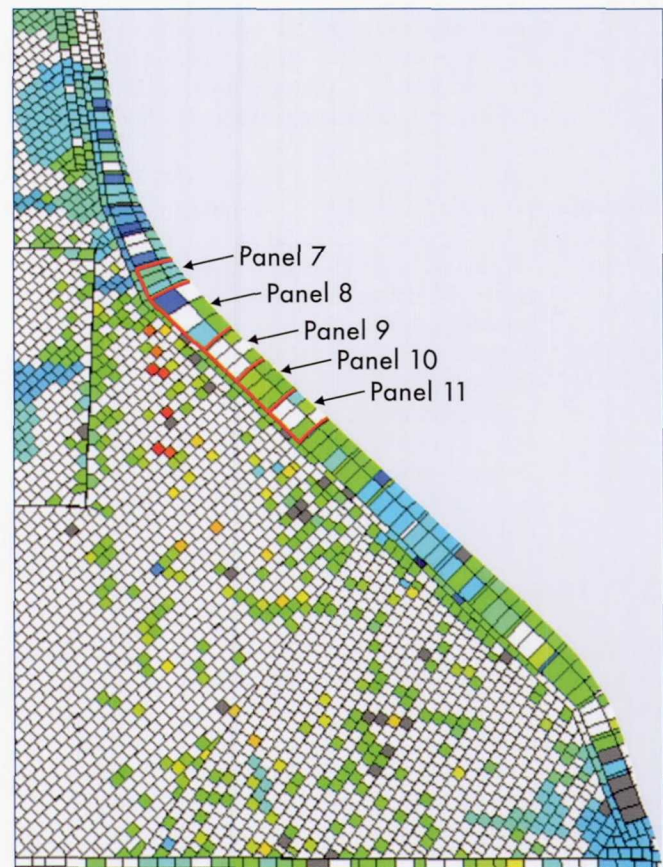
Figure 3.7-6. The tiles recovered farthest west all came from the area immediately behind left wing RCC panels 8 and 9. In the figure, each small box represents an individual tile on the lower surface of the left wing. The more red an individual tile appears, the farther west it was found.

An analysis of where tiles were found on the ground also yielded significant evidence of the breach location. Since most of the tiles are of similar size, weight, and shape, they would all have similar ballistic coefficients and would have behaved similarly after they separated from the Orbiter. By noting where each tile fell and then plotting its location on the Orbiter tile map, a distinctive pattern emerged. The tiles recovered farthest west all came from the area immediately behind the left wing RCC panel 8 and 9 (see Figure 3.7-6), which suggests that these tiles were released earlier than those from other areas of the left wing. While it is not conclusive evidence of a breach in this area, this pattern does suggest unique damage around RCC panels 8 and 9 that was not seen in other areas. Tiles from this area also showed evidence of a brown deposit that was not seen on tiles from any

other part of the Orbiter. Chemical analysis revealed it was an Inconel-based deposit that had come from inside the RCC cavity on the left wing (Inconel is found in wing leading edge attachment fittings). Since the streamlines from tiles with the brown deposit originate near left RCC panels 8 and 9, this brown deposit likely originated as an outflow of superheated air and molten metal from the panel 8 and 9 area.

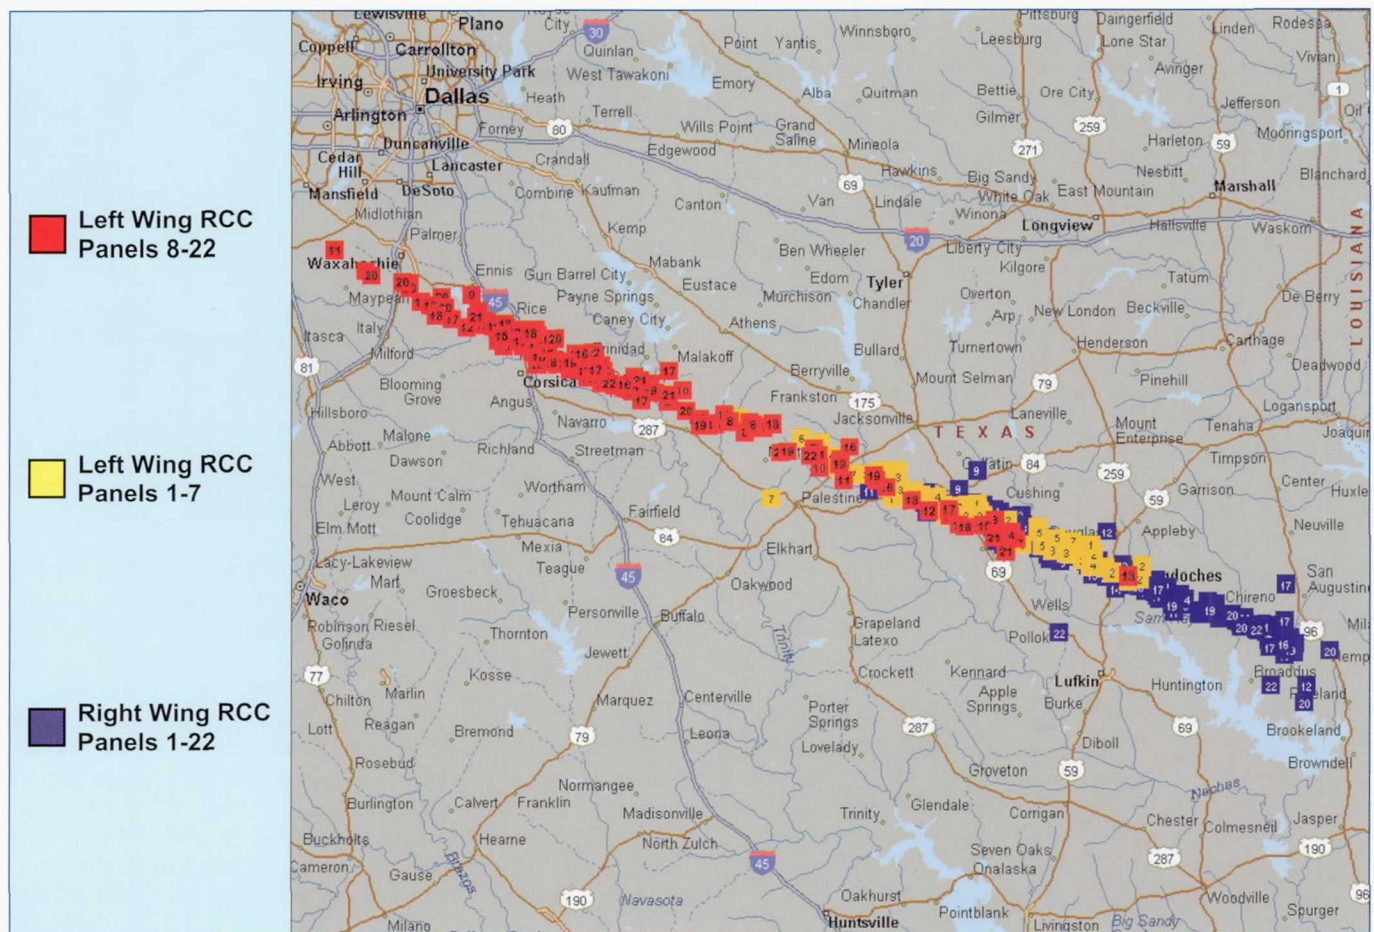
The location of debris on the ground also provided evidence of where the initial breach occurred. The location of every piece of recovered RCC was plotted on a map and labeled according to the panel the piece originally came from. Two distinct patterns were immediately evident. First, it was clear that pieces from left wing RCC panels 9 through 22 had fallen the farthest west, and that RCC from left wing panels 1 through 7 had fallen considerably farther east (see Figure 3.7-5). Second, pieces from left wing panel 8 were

Figure 3.7-5. The location of RCC panel debris from the left and right wings, shown where it was recovered from in East Texas. The debris pattern suggested that the left wing failed before the right wing, most likely near left RCC panels 8 and 9.

found throughout the debris field, which suggested that the left wing likely failed in the vicinity of RCC panel 8. The early loss of the left wing from RCC panel 9 and outboard caused the RCC from that area to be deposited well west of the RCC from the inboard part of the wing. Since panels 1 through 7 were so much farther to the east, investigators concluded that RCC panels 1 through 7 had stayed with the Orbiter longer than had panels 8 through 22.

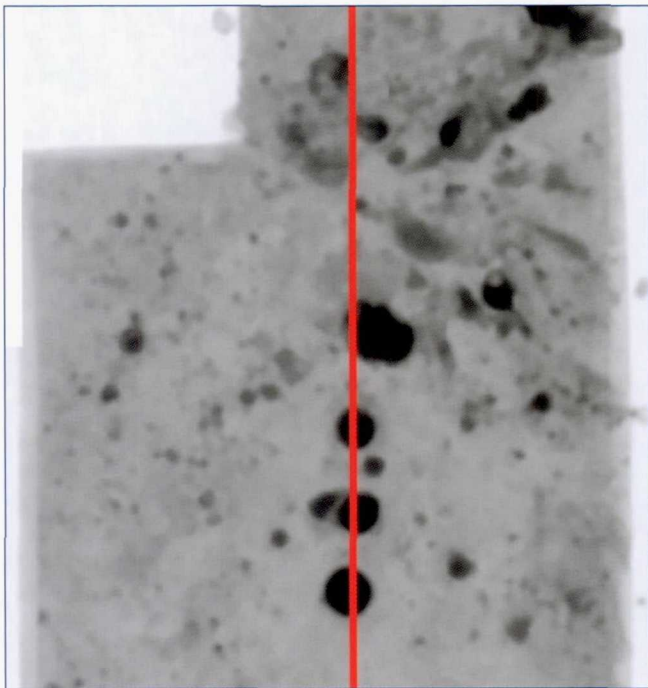
The X-ray analysis of left wing RCC panel 8 (see Figure 3.7-7) showed a bottom-to-top pattern of slag deposits. In some areas, small spheroids of heavy metal were aligned vertically on the recovered pieces, which indicated a superheated airflow from the bottom of the panel toward the top in the area of RCC panel 8-left. These deposits were later determined by chemical analysis to be Inconel 718, probably from the wing leading edge attachment fittings on the spanner beams on RCC panels 8 and 9. Computational fluid dynamics modeling of the flow behind panel 8 indicated that the molten deposits would be laid down in this manner.

Figure 3.7-7. X-ray analysis of RCC panel 8-left showed a bottom-to-top pattern of slag deposits.

The layered deposits on panel 8 were also markedly different from those on all other left- and right-wing panels. There was much more material deposited on RCC panel 8-left. These deposits had a much rougher overall structure, including rivulets of Cerachrome slag deposited directly on the RCC. This indicated that Cerachrome, the insulation that protects the wing leading edge spar, was one of the first materials to succumb to the superheated air entering through the breach in RCC panel 8-left. Because the melting temperature of Cerachrome is greater than 3,200 degrees Fahrenheit, analysis indicated that materials in this area were exposed to extremely

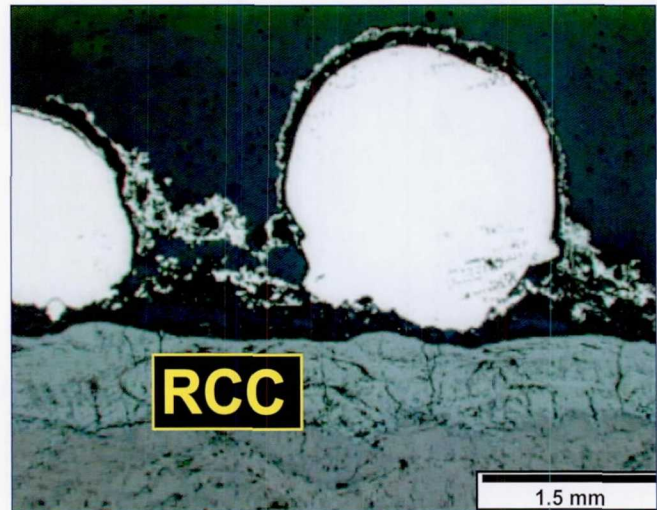
Figure 3.7-8. Spheroids of Inconel 718 and Cerachrome were deposited directly on the surface of RCC panel 8-left. This slag deposit pattern was not seen on any other RCC panels.

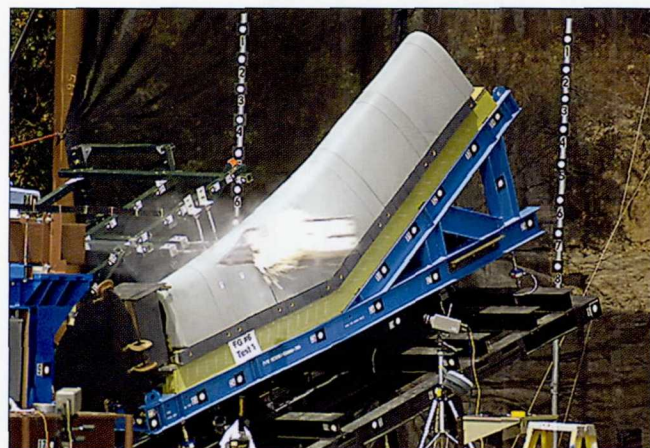
Figure 3.8-5. A typical foam strike leaves impact streaks, and the foam projectile breaks into shards and larger pieces. Here the foam is striking Panel 6 on a fiberglass test article.

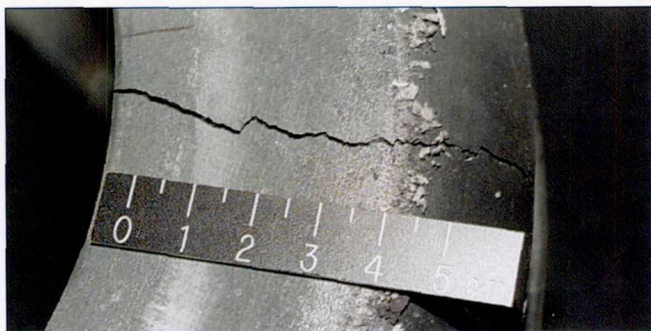
RCC panel 6 was tested first to begin to establish RCC impact response, although by the time of the test, other data had indicated that RCC panel 8-left was the most likely site of the breach. RCC panel 6 was impacted using the same parameters as the test on fiberglass panel 6 and developed a 5.5-inch crack on the outboard end of the panel that extended through the rib (see Figure 3.8-6). There was also a crack through the "web" of the T-seal between panels 6 and 7 (see Figure 3.8-7). As in the fiberglass test, the foam block deflected, or moved, the face of the RCC panel, creating a slit between the panel and the adjacent T-seal, which ripped the projectile and stuffed pieces of foam into the slit (see Figure 3.8-8). The panel rib failed at lower stresses than predicted, and the T-seal failed closer to predictions, but overall, the stress pattern was similar to what was predicted, demonstrating the need to incorporate more complete RCC failure criteria in the computational models.

Without further crack growth, the specific structural damage this test produced would probably not have allowed enough superheated air to penetrate the wing during re-entry to cause serious damage. However, the test did demonstrate that a foam impact representative of the debris strike at 81.9 seconds after launch could damage an RCC panel. Note that

Figure 3.8-6. A 5.5-inch crack on the outboard portion of RCC Panel 6 during testing.

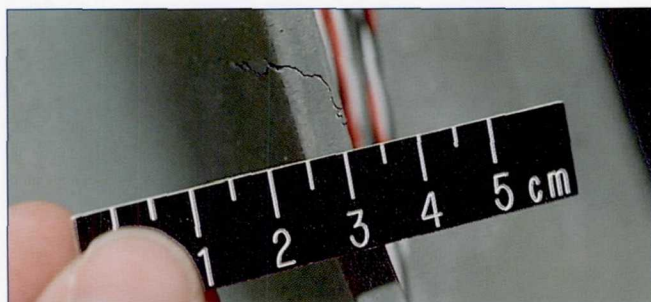
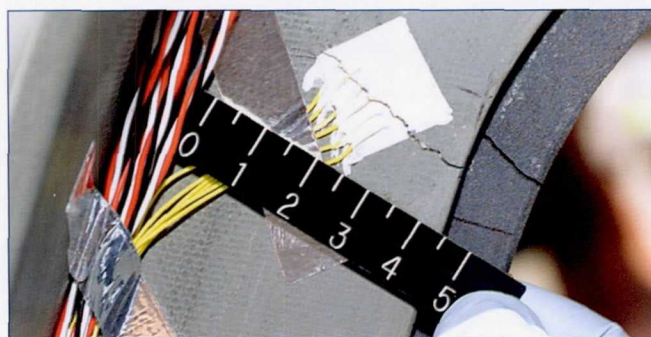
Figure 3.8-7. Two views of the crack in the T-seal between RCC Panels 6 and 7.

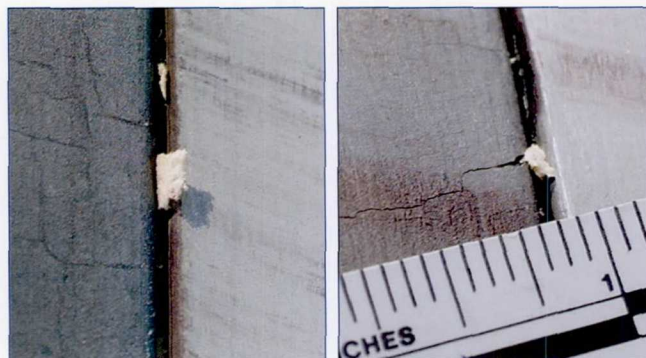
Figure 3.8-8. Two views of foam lodged into the slit during tests.

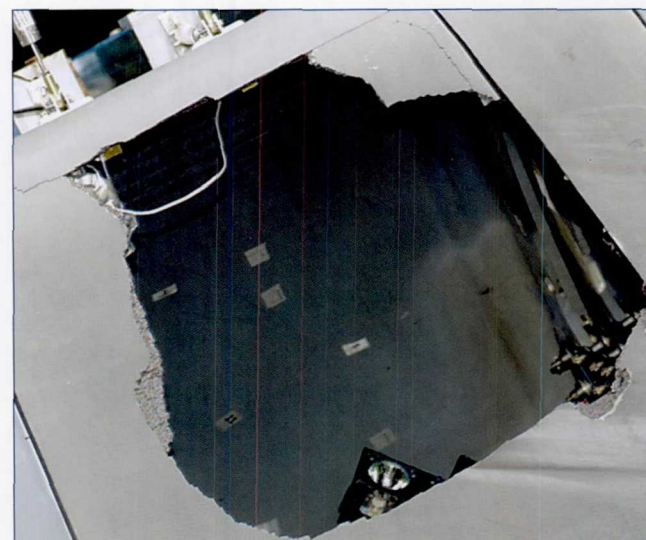
Figure 3.8-9. The large impact hole in Panel 8 from the final test.

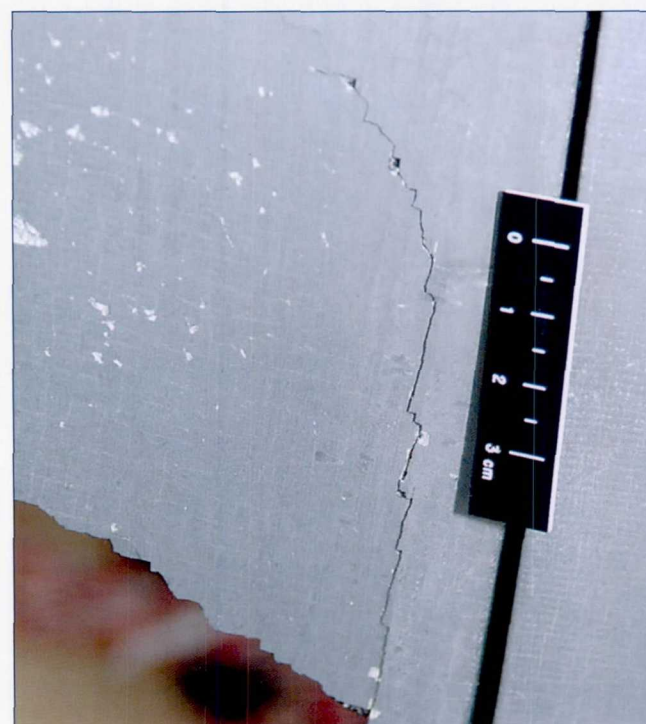
Figure 3.8-10. Numerous cracks were also noted in RCC Panel 8.

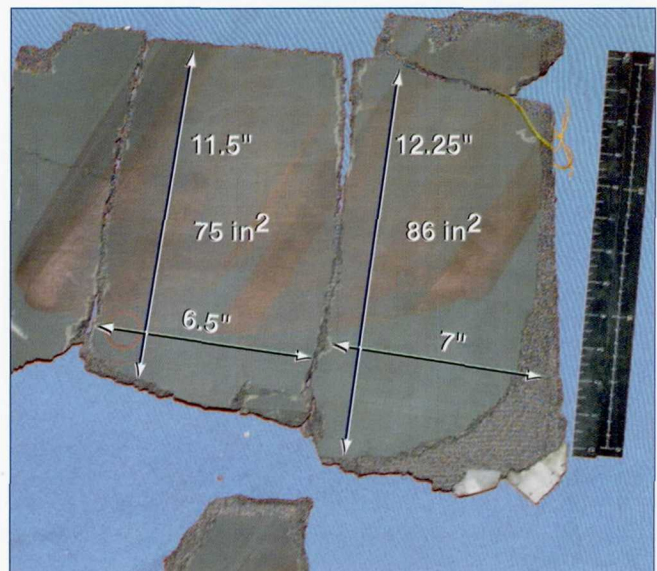
Figure 3.8-11. Three large pieces of debris from the panel face sheet were lodged within the hollow area behind the RCC panel.

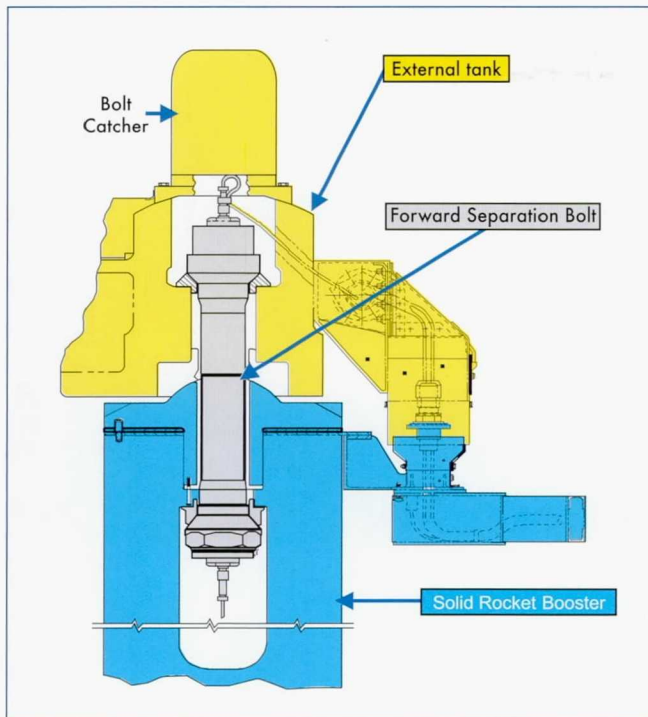
If one of the bolt catchers failed during STS-107, the resulting debris could have damaged *Columbia*'s wing leading edge. Concerns that the bolt catchers may have failed, causing metal debris to ricochet toward the Orbiter, arose because the configuration of the bolt catchers used on Shuttle missions differs in important ways from the design used in

Figure 4.2-1. A cutaway drawing of the forward Solid Rocket Booster bolt catcher and separation bolt assembly.

Due to these testing deficiencies, the Board recognized that bolt catchers could have played a role in damaging *Columbia*’s left wing. The aluminum dome could have failed catastrophically, ablative coating could have come off in large quantities, or the device could have failed to hold to its mount point on the External Tank. To determine whether bolt catchers should be eliminated as a source of debris, investigators conducted tests to establish a performance baseline for bolt catchers in their current configuration and also reviewed radar data to see whether bolt catcher failure could be observed. The results had serious implications: Every bolt catcher tested failed well below the expected load range of 68,000 pounds. In one test, a bolt catcher failed at 44,000 pounds, which was two percent below the 46,000 pounds

Although bolt catchers can be neither definitively excluded nor included as a potential cause of left wing damage to *Columbia*, the impact of such a large object would likely have registered on the Shuttle stack's sensors. The indefinite data at the time of Solid Rocket Booster separation, in tandem with overwhelming evidence related to the foam debris strike, leads the Board to conclude that bolt catchers are unlikely to have been involved in the accident.

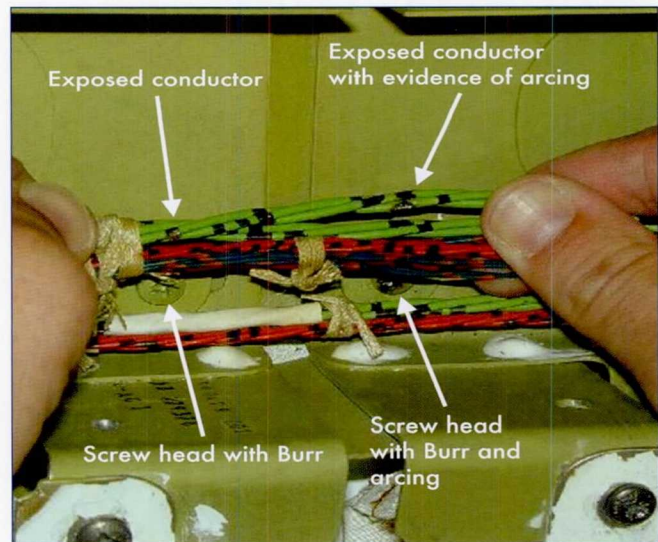
Figure 4.2-2. Arc tracking damage in Kapton wiring.

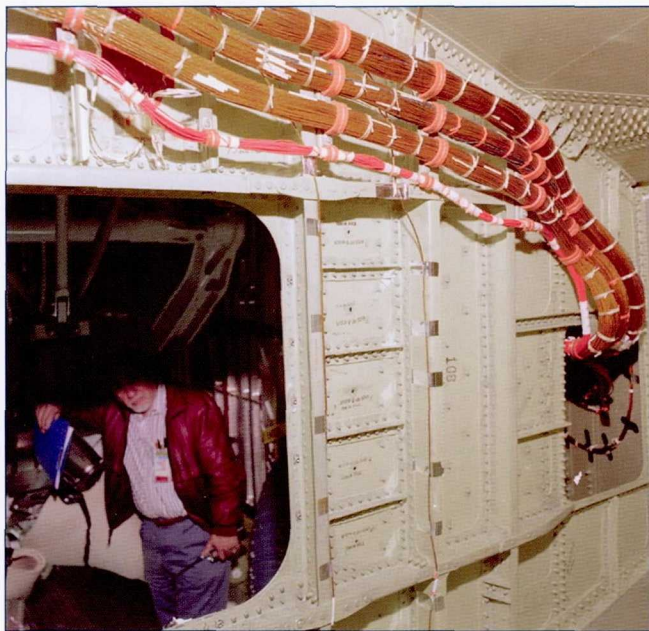
Figure 4.2-3. Typical wiring bundle inside Orbiter wing.

A typical wiring bundle is shown in Figure 4.2-3. Wiring nonconformances are corrected by rerouting, reclamping, or installing additional insulation such as convoluted tubing, insulating tape, insulating sheets, heat shrink sleeving, and abrasion pads (see Figure 4.2-4). Testing has shown that wiring bundles usually stop arc tracking when wires are physically separated from one another. Further testing under conditions simulating the Shuttle's wiring environment demonstrated that arc tracking does not progress beyond six inches. Based on these results, Boeing recommended that NASA separate all critical paths from larger wire bundles and individually protect them for a minimum of six inches beyond their separation points.<sup>4</sup> This recommendation is being adopted through modifications performed during scheduled Orbiter Major Modifications. For example, analysis of telemetered data from 14 of *Columbia's* left wing sensors (hydraulic line/wing skin/wheel temperatures, tire pressures, and landing gear downlock position indication) provided failure signatures supporting the scenario of left-wing thermal intrusion, as opposed to a catastrophic failure (extensive arc tracking) of Kapton wiring. Actual NASA testing in the months following the accident, during which wiring bundles were subjected to intense heat (ovens, blowtorch, and arc jet), verified the failure signature analyses. Finally, extensive testing and analysis in years prior to STS-107 showed that, with the low currents and low voltages associated with the Orbiter's instrumentation system (such as those in the left wing), the probability of arc tracking is commensurately low.

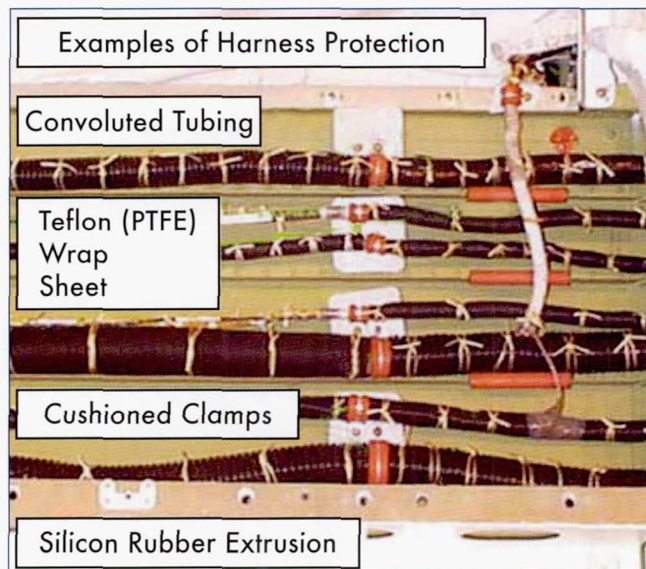
Figure 4.2-4. Typical wiring harness protection methods.

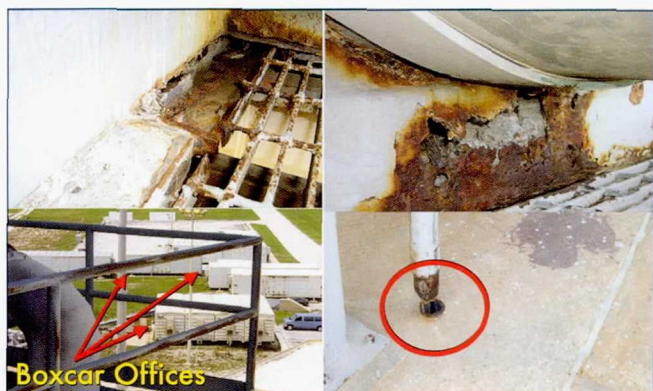
Board investigators have identified deteriorating infrastructure associated with the launch pads, Vehicle Assembly Building, and the crawler transporter. Figures 5.5-5 and 5.5-6 depict some of this deterioration. For example, NASA has installed nets, and even an entire sub-roof, inside the Vehicle Assembly Building to prevent concrete from the building’s ceiling from hitting the Orbiter and Shuttle stack. In addition, the corrosion-control challenge results in zinc primer

on certain launch pad areas being exposed to the elements. When rain falls on these areas, it carries away zinc, runs onto the leading edge of the Orbiter's wings, and causes pinholes in the Reinforced Carbon-Carbon panels (see Chapter 3).

Figure 5.5-5 and 5.5-6. Examples of the seriously deteriorating infrastructure used to support the Space Shuttle Program. At left is Launch Complex 39A, and at right is the Vehicle Assembly building, both at the Kennedy Space Center.

In Fiscal Year 2002, Congress added \$25 million to NASA's budget for Vehicle Assembly Building repairs. NASA has reallocated limited funds from the Shuttle budget to pressing infrastructure repairs, and intends to take an integrated look at infrastructure as part of its new Shuttle Service Life Extension Program. Nonetheless, like Space Shuttle upgrades, infrastructure revitalization has been mired by the uncertainty surrounding the Shuttle Program's lifetime. Considering that the Shuttle will likely be flying for many years to come, NASA, the White House, and Congress alike now face the specter of having to deal with years of infrastructure neglect.

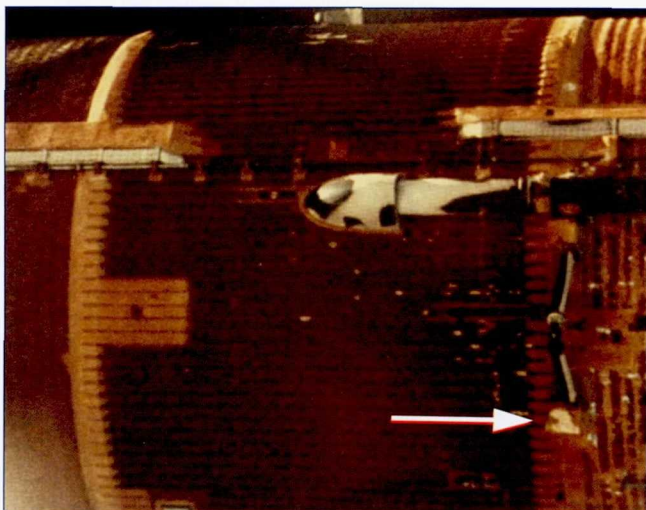
Figure 6.1-2. The first known instance of bipod ramp shedding occurred on STS-7 which was launched on June 18, 1983.

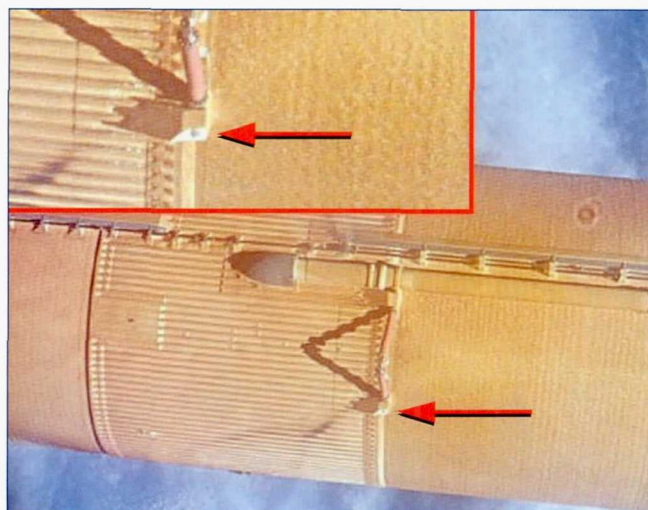
Figure 6.1-3. Only three months before the final launch of Columbia, the bipod ramp foam had come off during STS-112.

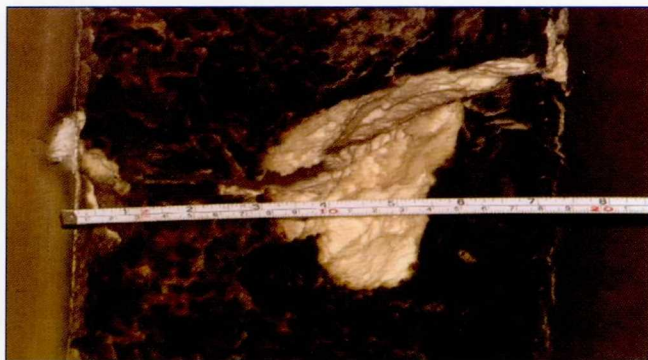
The sixth and final bipod ramp event before STS-107 occurred during STS-112 on October 7, 2002 (see Figure 6.1-3). At 33 seconds after launch, when *Atlantis* was at 12,500 feet and traveling at Mach 0.75, ground cameras observed an object traveling from the External Tank that subsequently impacted the Solid Rocket Booster/External Tank Attachment ring (see Figure 6.1-4). After impact, the debris broke into multiple pieces that fell along the Solid Rocket Booster exhaust plume.<sup>15</sup> Post-mission inspection of the Solid Rocket Booster confirmed damage to foam on the forward face of the External Tank Attachment ring. The impact was approximately 4 inches wide and 3 inches deep. Post-External Tank separation photography by the crew showed that a 4- by 5- by 12-inch (240 cubic-inch) corner section of the left bipod ramp was missing, which exposed the super lightweight ablator coating on the bipod housing. This missing chunk of foam was believed to be the debris that impacted the External Tank Attachment ring during ascent. The post-launch review of photos and video identified these debris events, but the Mission Evaluation Room logs and Mission Management Team minutes do not reflect any discussions of them.

Figure 6.1-4. On STS-112, the foam impacted the External Tank Attach ring on the Solid Rocket Booster, causing this tear in the insulation on the ring.

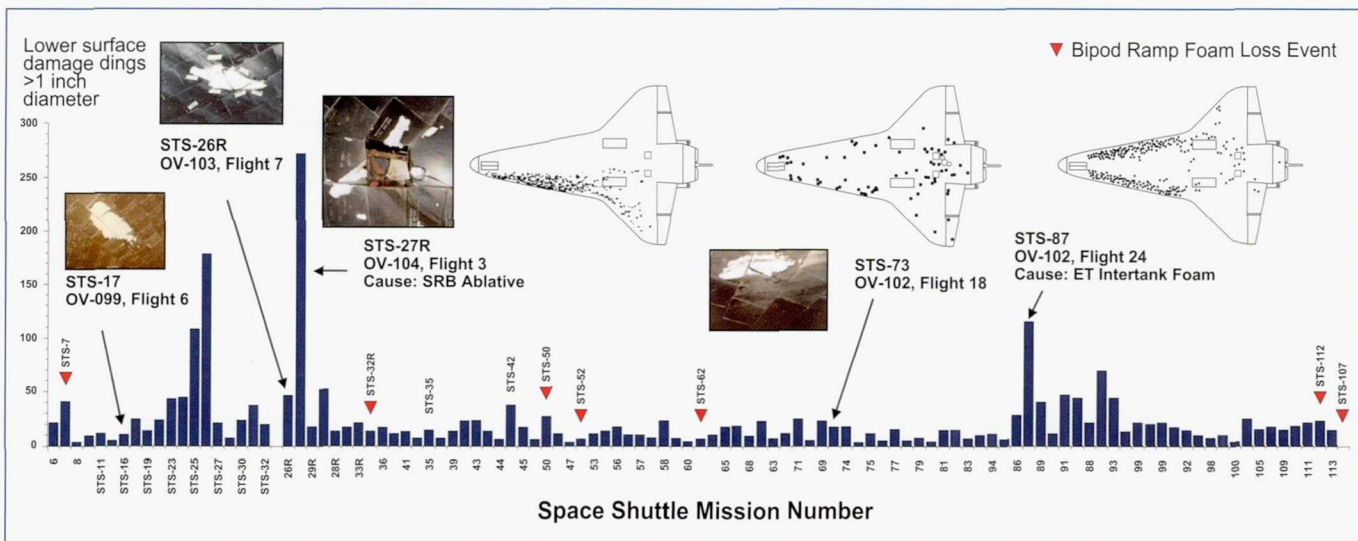
Figure 6.1-6. This chart shows the number of dings greater than one inch in diameter on the lower surface of the Orbiter after each mission from STS-6 through STS-113. Flights where the bipod ramp foam is known to have come off are marked with a red triangle.

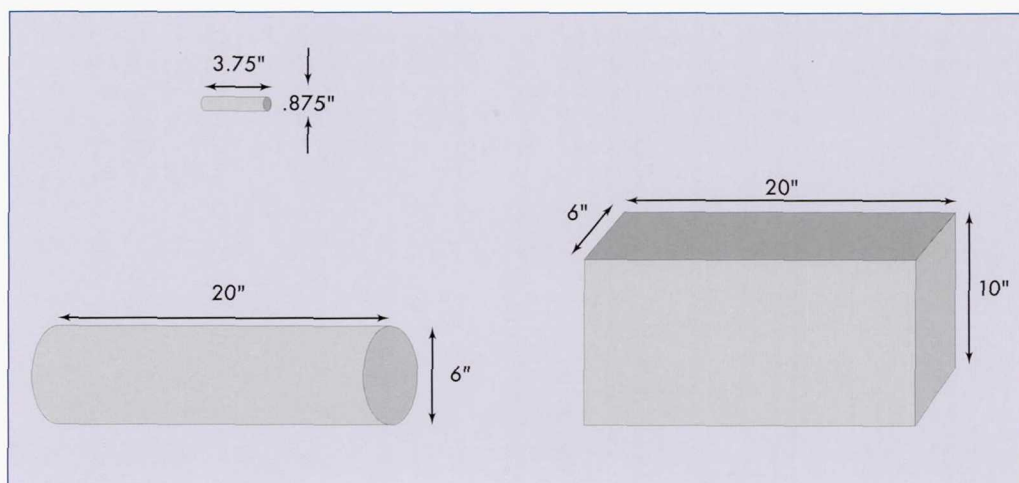
Until STS-107, Crater was normally used only to predict whether small debris, usually ice on the External Tank, would pose a threat to the Orbiter during launch. The use of Crater to assess the damage caused by foam during the launch of STS-107 was the first use of the model while a mission was on orbit. Also of note is that engineers used Crater during STS-107 to analyze a piece of debris that was at maximum 640 times larger in volume than the pieces of debris used to calibrate and validate the Crater model (the Board's best estimate is that it actually was 400 times larger). Therefore, the use of Crater in this new and very different situation compromised NASA's ability to accurately predict debris damage in ways that Debris Assessment Team engineers did not fully comprehend (see Figure 6.3-1).

Figure 6.3-1. The small cylinder at top illustrates the size of debris Crater was intended to analyze. The larger cylinder was used for the STS-107 analysis; the block at right is the estimated size of the foam.

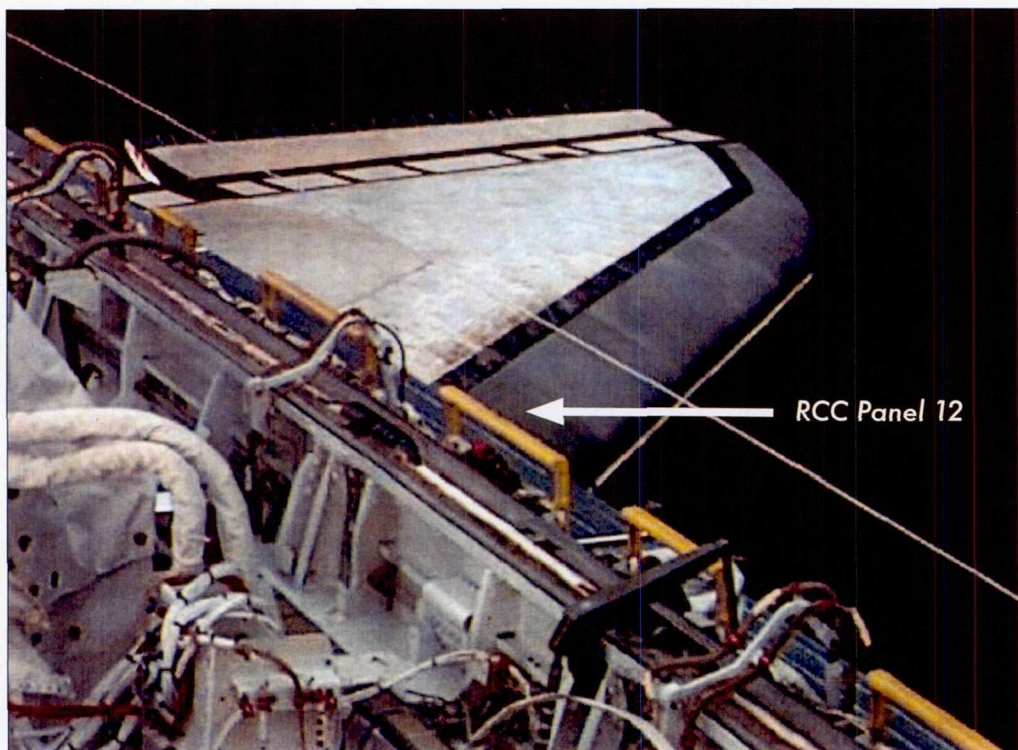
This photo from the aft flight deck window of an Orbiter shows that RCC panels 1 – 11 are not visible from inside the Orbiter. Since Columbia did not have a manipulator arm for STS-107, it would have been necessary for an astronaut to take a spacewalk to visibly inspect the inboard leading edge of the wing.

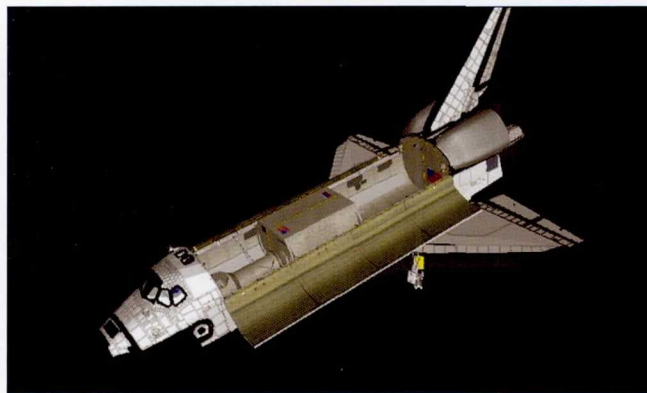
Figure 6.4-1. The speculative repair option would have sent astronauts hanging over the payload bay door to reach the left wing RCC panels using a ladder scavenged from the crew module.

The repair option (see Figure 6.4-1), while logistically viable using existing materials onboard *Columbia*, relied on so many uncertainties that NASA rated this option "high risk." To complete a repair, the crew would perform a spacewalk to fill an assumed 6-inch hole in an RCC panel with heavy metal tools, small pieces of titanium, or other metal scavenged from the crew cabin. These heavy metals, which would help protect the wing structure, would be held in place during

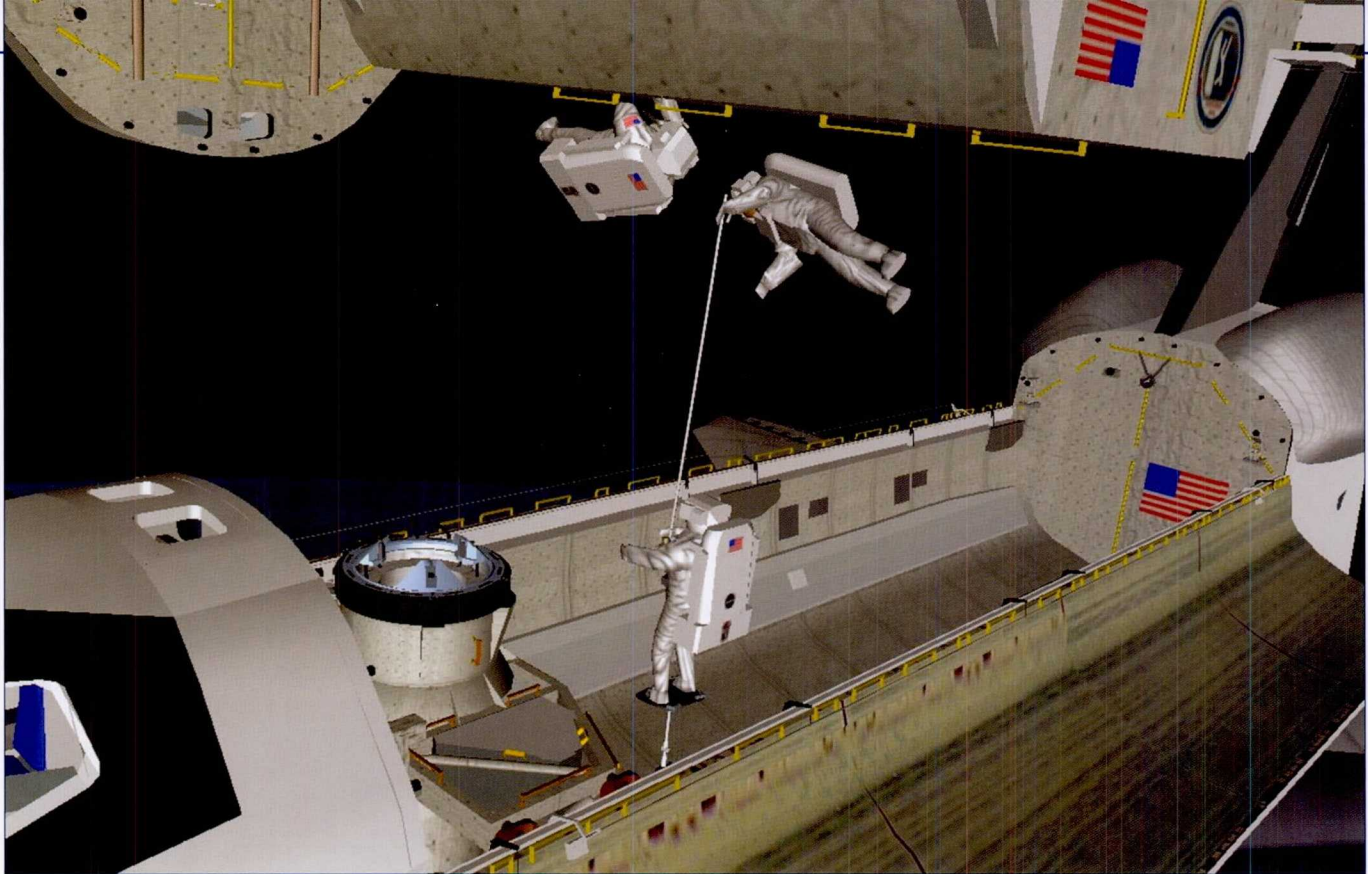
Figure 6.4-2. The rescue option had Atlantis (lower vehicle) rendezvousing with Columbia and the STS-107 crew transferring via ropes. Note that the payload bay of Atlantis is empty except for the external airlock/docking adapter.

er, pilot, and two astronauts trained for spacewalks. In January, seven commanders, seven pilots, and nine spacewalk-trained astronauts were available. During the rendezvous on *Atlantis*'s first day in orbit, the two Orbiters would maneuver to face each other with their payload bay doors open (see Figure 6.4-2). Suited *Columbia* crew members would then be transferred to *Atlantis* via spacewalks. *Atlantis* would return with four crew members on the flight deck and seven in the mid-deck. Mission Control would then configure *Columbia* for a de-orbit burn that would ditch the Orbiter in the Pacific Ocean, or would have the *Columbia* crew take it to a higher orbit for a possible subsequent repair mission if more thorough repairs could be developed.

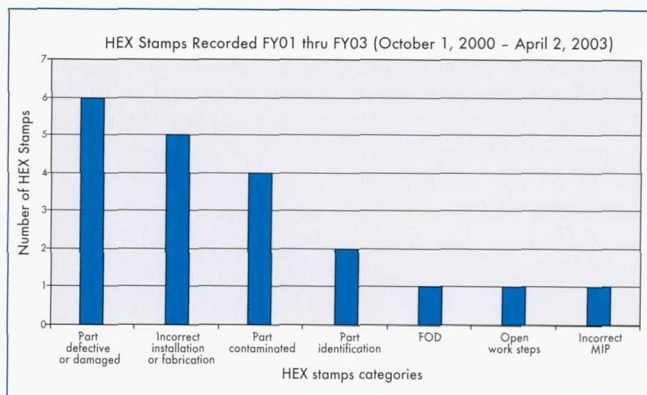
Of the 141,127 inspections subject to rejection from October 2000 through March 2003, only 20 rejections, or "hexes," were recorded, resulting in a statistically improbable discrepancy rate of .014 percent (see Figure 10.4-4). In interviews, technicians and inspectors alike confirmed the dubiousness of this rate. NASA's published rejection rate therefore indicates either inadequate documentation or an underused system. Testimony further revealed incidents of quality assurance inspectors being played against each other to accept work that had originally been refused.

Figure 10.4-4. Rejection, or "Hex" stamps issued from October 2000 through April 2003.
